BIAXIAL TESTING OF GRAPHITE/EPOXY COMPOSITES CONTAINING STRESS CONCENTRATIONS

IIT RESEARCH INSTITUTE
10 W. 35th STREET
CHICAGO, ILLINOIS 60616

TECHNICAL REPORT AFML-TR-76-244
FINAL REPORT FOR PERIOD APRIL 1975 - SEPTEMBER 1976

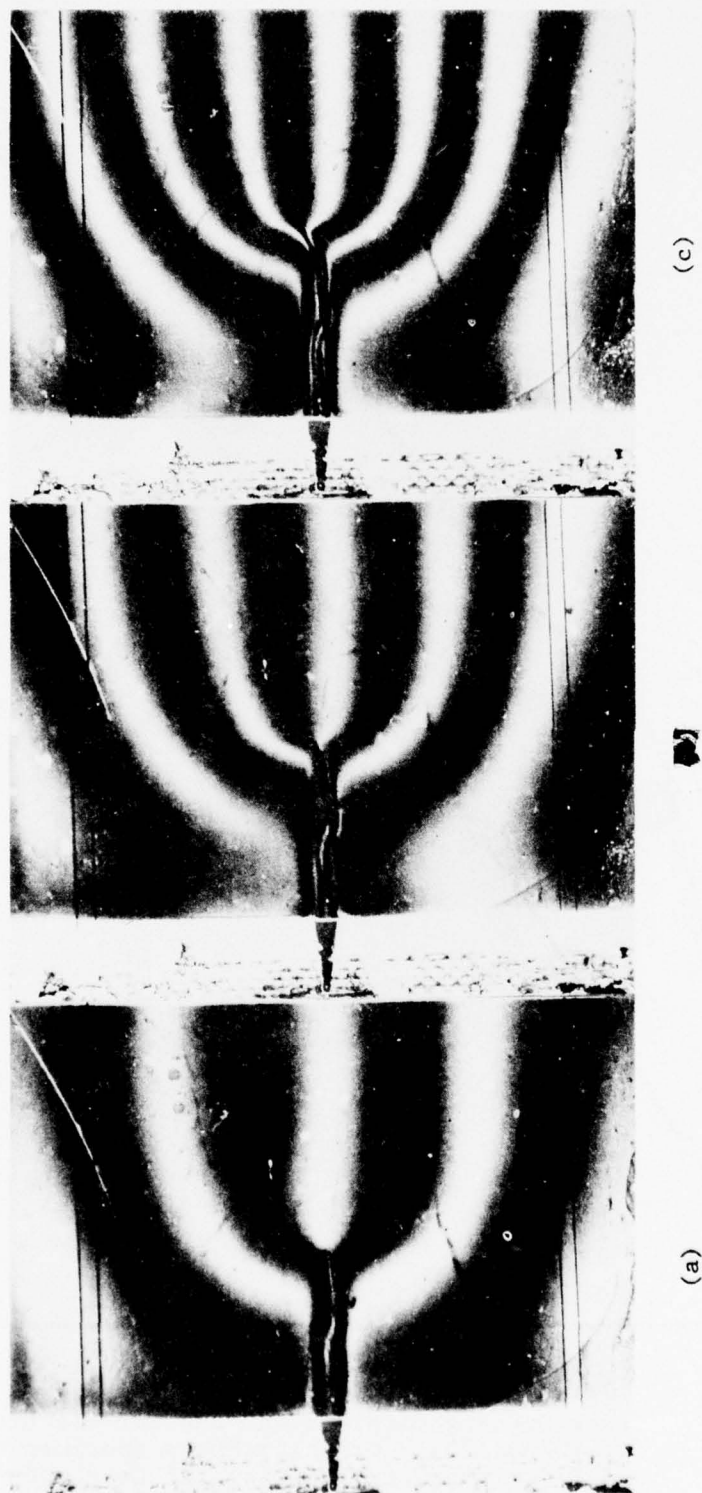
Figure 56. Moiré Fringe Patterns Around Crack in Uniaxially Loaded $[0/+45/90]_s$ Graphite/Epoxy Specimen for Three Levels of Applied Stress: (a) $\sigma_{xx} = 152 \text{ MPa}$ (22 ksi), (b) $\sigma_{xx} = 202 \text{ MPa}$ (29 ksi), (c) $\sigma_{xx} = 253 \text{ MPa}$ (37 ksi) (Spec. No. 4-14).

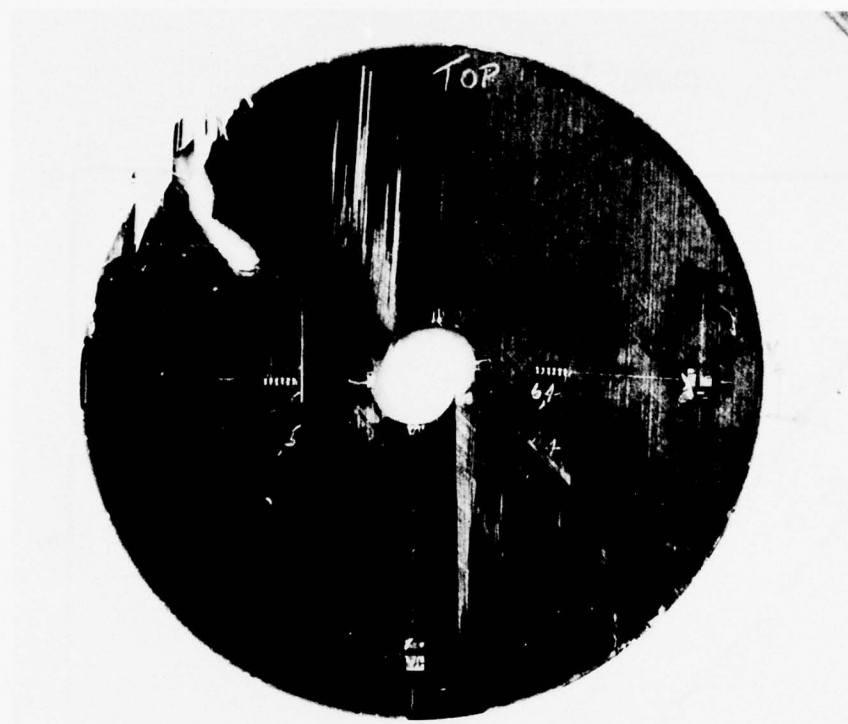
Figure 85. Failure Pattern in $[0/\pm 45/90]_s$ Graphite/Epoxy Specimen with 2.54 cm (1 in.) Diameter Hole Under Equal Biaxial Loading (Spec. No. 6-7).

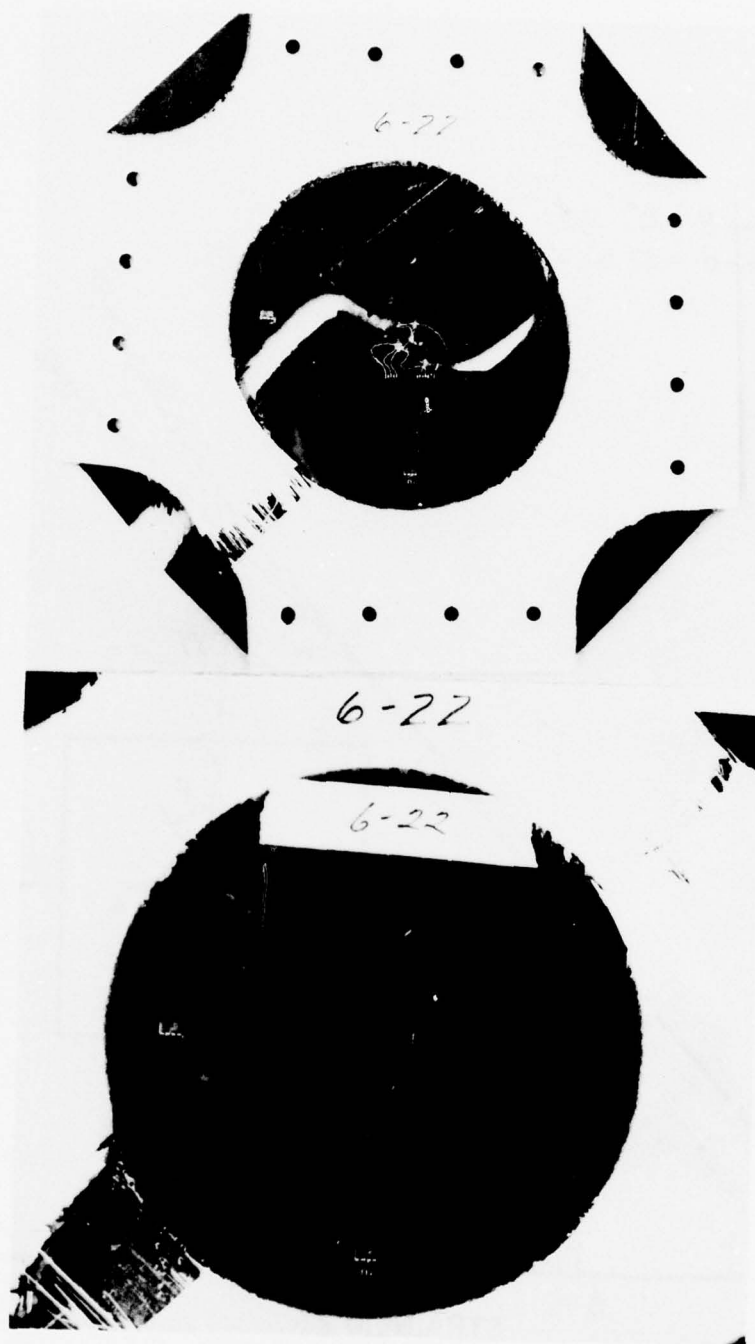
Figure 113. Failure Pattern in $[0/\pm 45/90]_s$ Graphite/Epoxy Specimen with 0.64 cm (0.25 in.) Diameter Hole Under Equal Biaxial Loading (Spec. No. 6-22).

Specimen No. 6-22 had a 0.64 cm (0.25 in.) diameter hole and was instrumented with strain gages and a 0.51 mm (0.020 in.) thick photoelastic coating. The variation of strains with effective far-field biaxial stress is shown in Figures 110 and 111. Strains on the boundary of the hole are linear up to an applied stress of approximately 97 MPa (14 ksi). Far-field strains are linear up to an applied stress of approximately 207 MPa (30 ksi). Isochromatic fringe patterns in the photoelastic coating around the hole were similar to those observed previously. The variation of fringe order and circumferential strain with effective stress at the 0-deg. and 22.5-deg. locations is shown in Figure 112. At the 0-deg. location the fringe order varies linearly up to an applied stress of approximately 276 MPa (40 ksi). At the 22.5-deg. location the fringe variation becomes nonlinear at a stress of approximately 214 MPa (31 ksi). The specimen failed at an applied biaxial stress of 349 MPa (50.6 ksi). Failure initiated at two points on the hole boundary at locations approximately 22.5-deg. off the horizontal axis (Figure 113).

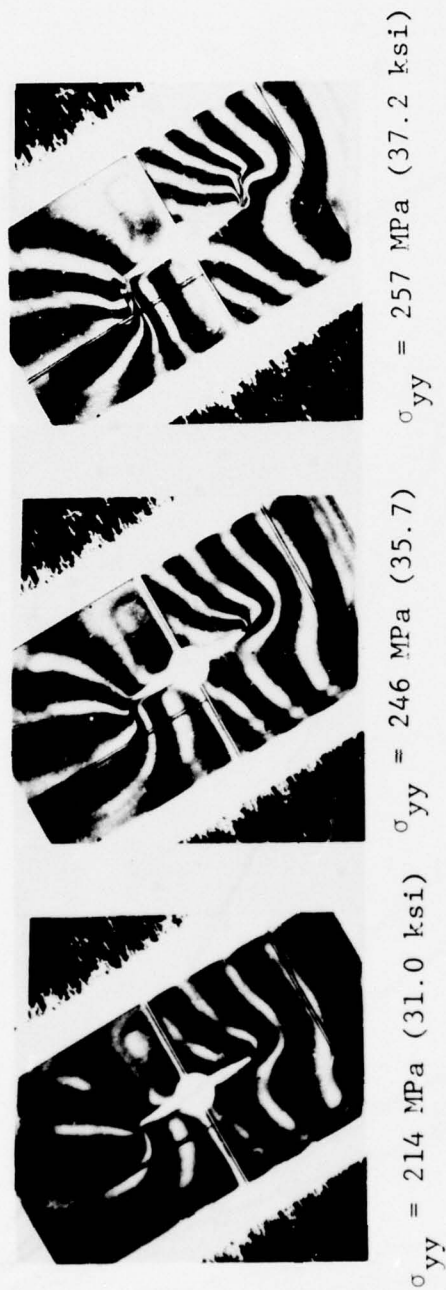
Figure 122. Moiré Fringe Patterns Around 2.54 cm (1 in.) Crack in [0/+45/90]_s Graphite/Epoxy Specimen Under Biaxial Loading $\sigma_{yy} = 1.98\sigma_{xx}$ at 30-Deg. with Crack Direction. (Upper part of pattern corresponds to displacements normal to the crack, lower part of pattern corresponds to displacements along the crack direction; Spec. No. 6-12).

Moiré fringe patterns around the crack are shown in Figure 122 for three load levels. The upper part of the pattern corresponds to displacements normal to the crack direction, the lower part to displacements parallel to it. By differentiating

the fringe patterns away from the crack the far-field strains shown in Figure 123 were obtained. Relative displacements between any two points can be obtained by the simple expedient of counting fringes. Thus, the crack opening displacement and the forward sliding or crack shearing displacement were determined and plotted as a function of applied stress (Figure 124). These displacements are of the same order of magnitude and they become nonlinear at an applied stress of approximately 172 MPa (25 ksi) which is close to the stress level of initial crack propagation as detected by the strain gages. The crack propagates normally to its initial direction or along the outer fibers as illustrated by the moiré fringe patterns. Total failure occurred at an applied stress of 264 MPa (38.3 ksi). The failure pattern is illustrated in Figure 125.

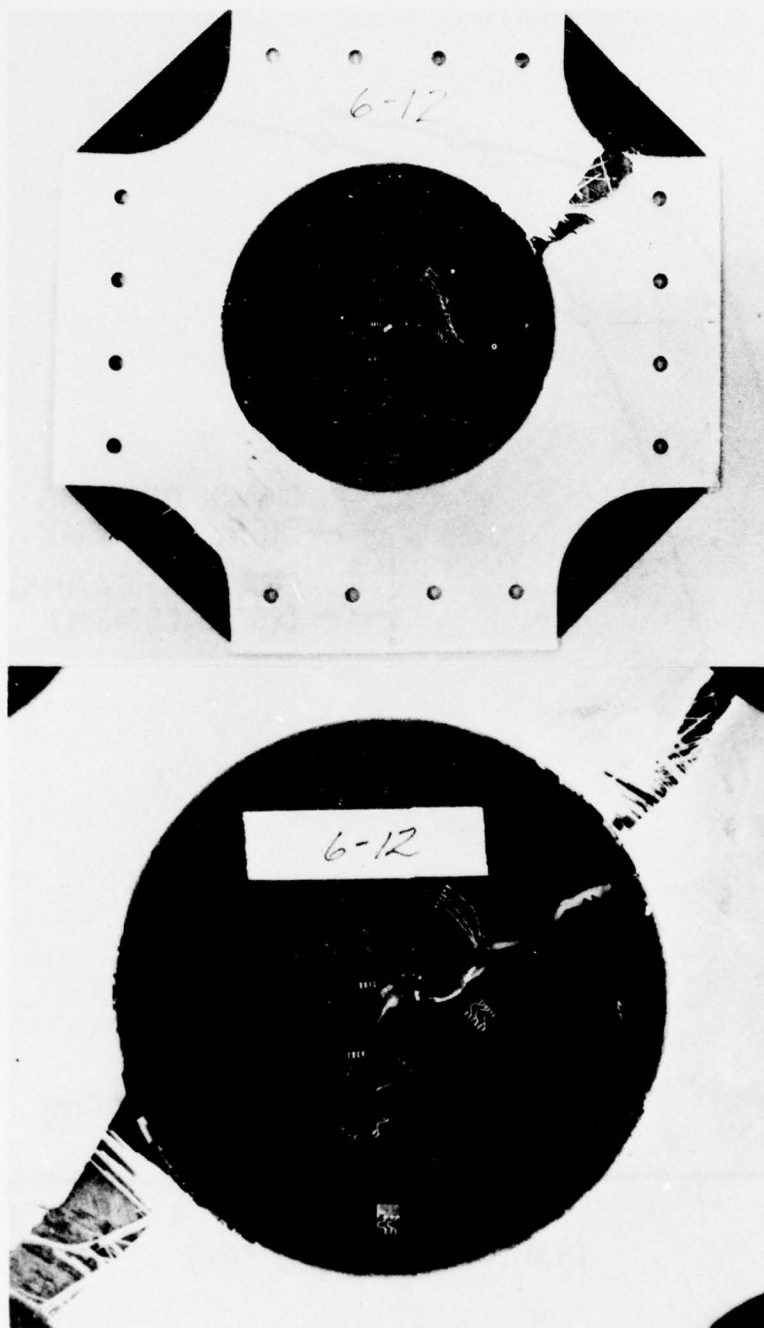
Figure 125. Failure Pattern in $[0/+45/90]_s$ Graphite/Epoxy Specimen with 2.54 cm (1.00 in.) Crack Under Biaxial Loading $\sigma_{yy} = 1.98\sigma_{xx}$ (Spec. No. 6-12)
